Assessment Report

Pedestrian, Bicycle, and Transit

City Of Lawrence, Kansas 19th Street from Iowa to Barker

Practical Road Safety Assessment

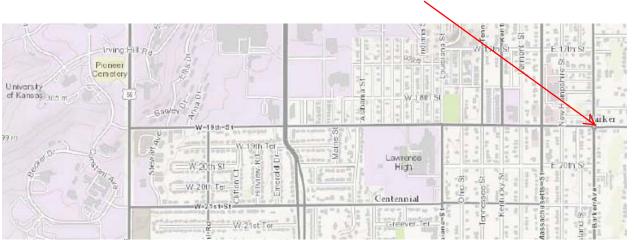
19th Street Assessment Corridor - Constant Avenue to Barker Avenue

Based on discussions with key partners in the Kansas Department of Transportation (KDOT) and the City of Lawrence (City), the 19th St. corridor from just west of Iowa St. (U.S. 59) at Constant Ave. east to the roundabout at Barker Ave. would be an ideal location for this effort. 19th St. is a two-lane minor arterial that provides an important east-west connection near the University of Kansas (KU) campus. See assessment area map below.

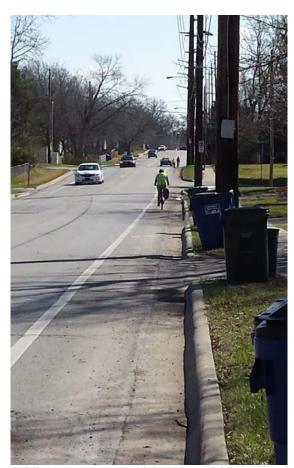
Bicycle: Except where there are bike lanes, bicyclists must share the road with high traffic volumes including commercial vehicles. Vehicles were observed not giving the required 3' passing clearance.

Discussion: This is generally a two lane street with a center turn lane from about Alabama St. to Kentucky St. and at other major intersections in the corridor. Two segments have bicycle lanes, between Naismith and Alabama and east of Massachusetts St. Only experienced riders should use 19th St., particularly from west of Tennessee to east of Kentucky where there is less than desirable pavement condition and an auxiliary lane which may cause confusion.

Bike lane between Naismith and Alabama.

<u>Lower Cost</u>: Consider a parallel alternate route on 21st St. for a bicycle boulevard. This much lower volume residential street would be safer and favorable to less experienced riders.

Initiate an education campaign to bring public attention to the 3' passing law. Suggest it correspond with the start of school in September.

Provide "Shared-Lane Marking" to fill gaps between segments with bike lanes particularly where lanes are too narrow for a bicyclist and a motorist to travel side-by-side and to eliminate any confusion as to where a bicyclist should be when extra lanes are present.

Provide timely street cleaning for bike lanes and along curb where a bicyclist will normal ride to remove sand and other debris.

<u>Higher Cost</u>: Reconstruct to 3-lanes with bike lanes (planned between Iowa and Naismith; but bike lanes are not shown on planning map).
